Master's Thesis

The structural intervention of
St. Torcato Church:
documentation and analysis
of the strengthening works

University of Minho

Year: 2014

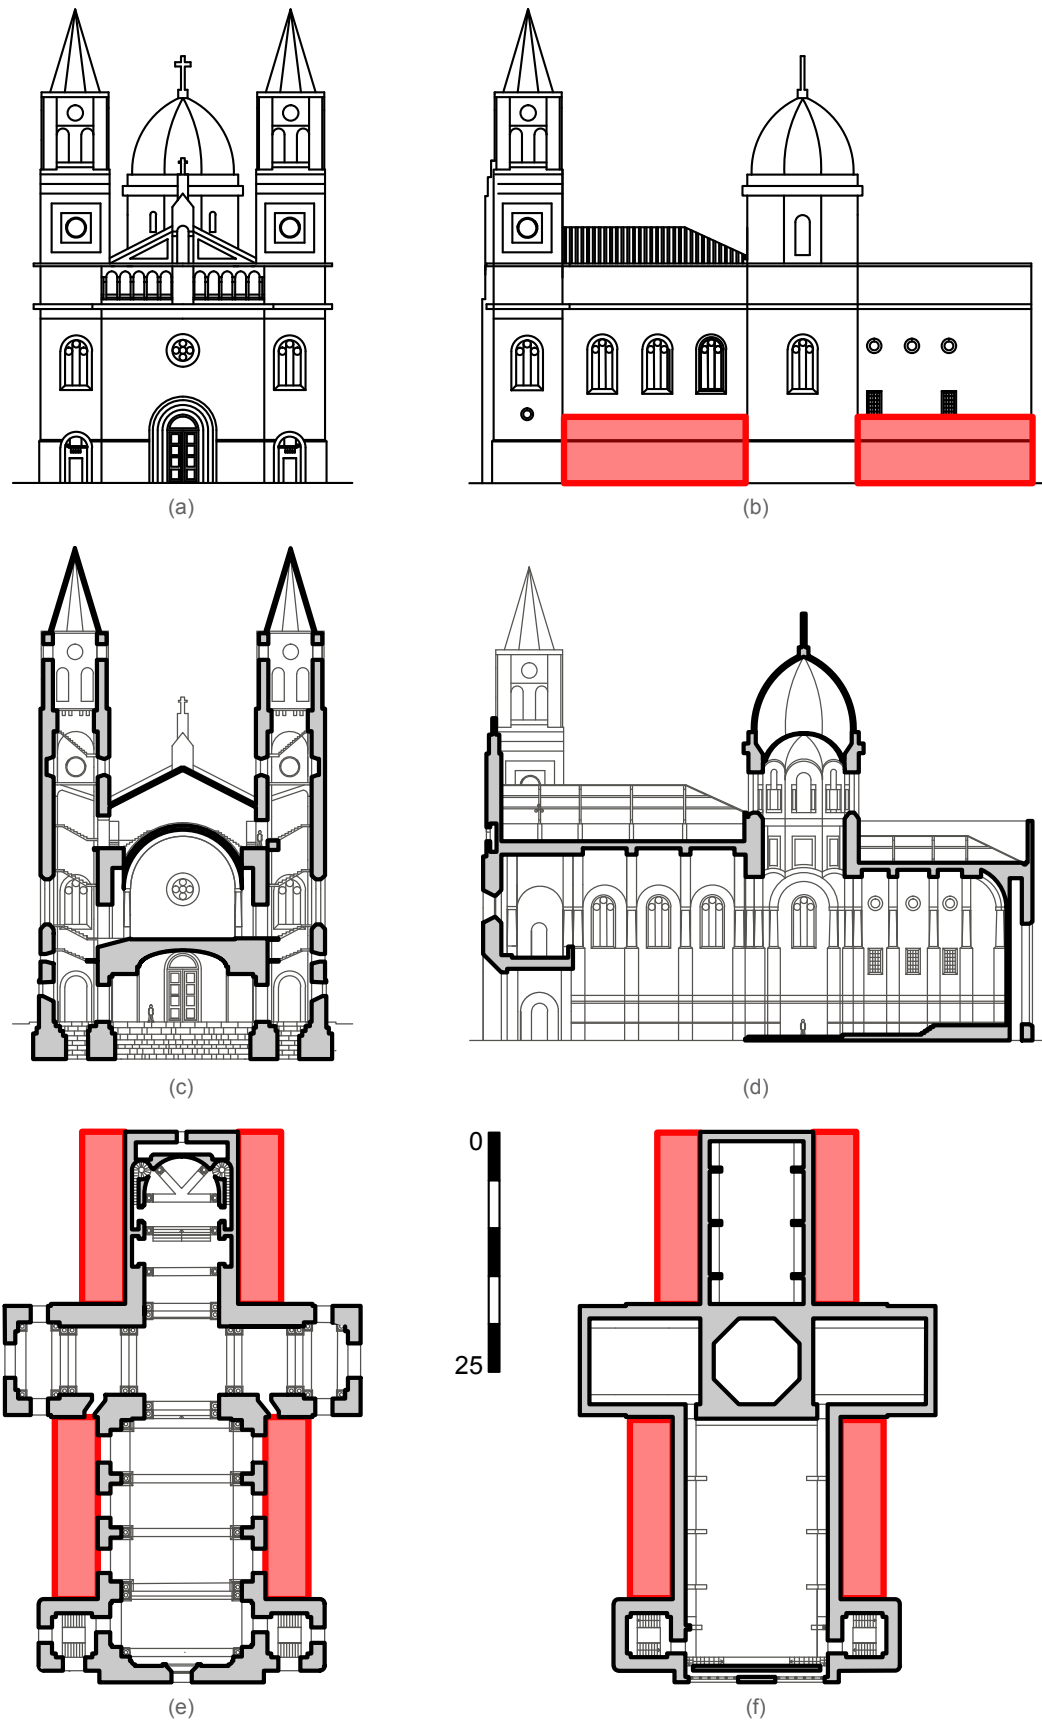
A mistake is visible both in the plants that in the elevation of the developed blueprints. There is in fact a lack of information regarding the lateral chapels of the main nave. Those volumes were built around

Figure 3.2: The blueprints resulting from the theodolite scanning, in red are marked the parts omitted during the analysis: (a) façade (b) eastern elevation (c) transversal section (d) longitudinal section (e) ground floor plan (f) roof plan

1875 (see Chapter 2) thus they were present during the scanning and should be identified by it (Figure 3.3). Even the apse part is not reliable with the real building for lack of information, but this point is more delicate because this part of the building was replaced in between the last thirty years, operation that could have been performed after the survey (see chapter 2.4). This omission could be attributed to a mistake during the scanning, a mistake during the transferring of the image from the CAD file to the report or even an arbitrary choice of separate those later additions with respect to the structural parts. However, recalling that the aim of the geometrical survey is the recovery of objective data, even the last hypothesis would be incorrect. This mistake, together with others, has been pointed and discussed by former SAHC students. Their consideration will be presented in the following paragraph.

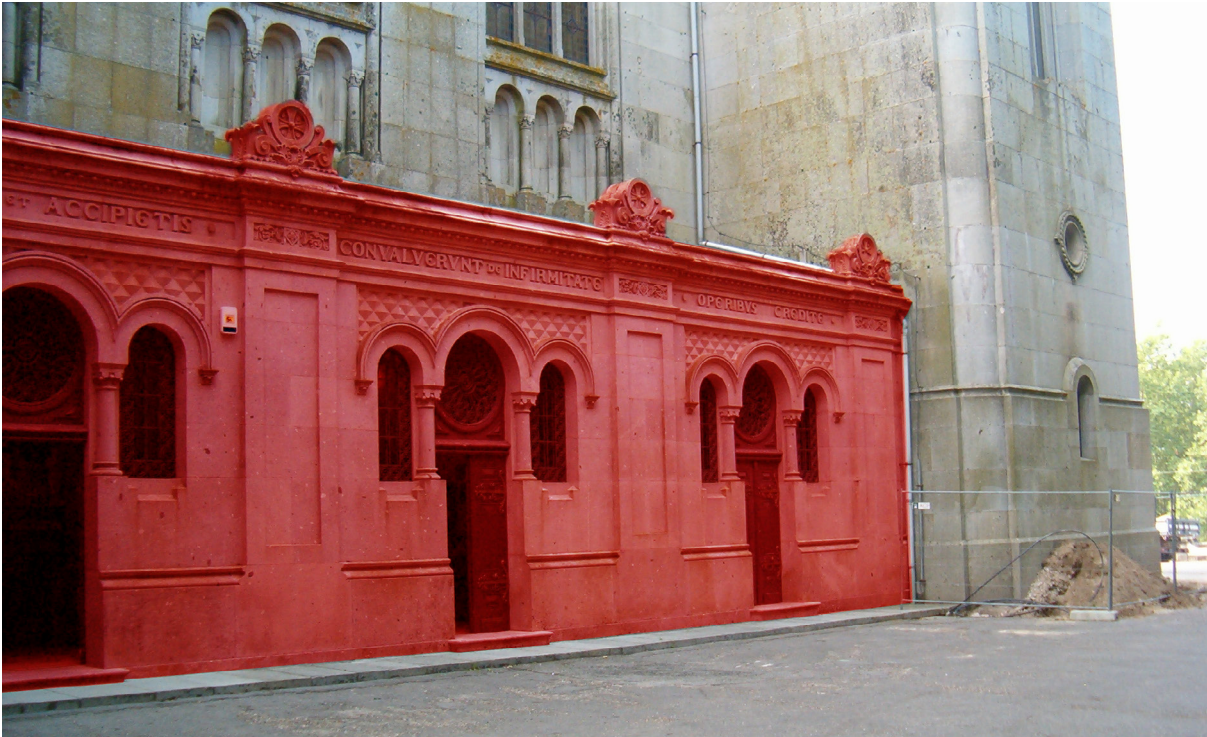
Figure 3.3: The parts omitted during theodolite scanning

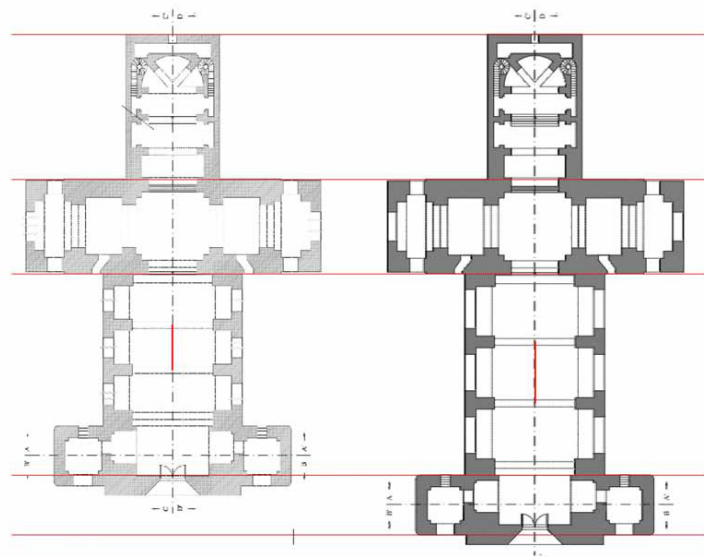
In the first semester of the present academic year the church was a case study during the “Inspection and Diagnosis” course of SAHC. During the survey performed by the students different measures were taken to check the existing blueprints. Various errors were discovered and reported to update the previous information. As previously mentioned, they noticed that some parts of the building were omitted and the dimensions in the drawings were not enough reliable. The main nave has a difference of two meters in height, resulting in a stretched drawing well exposed in the following figures. Several minor mistakes are described in the student reports. The difference of more than 6 meter in length with respect to real measurements can be considered as a “test” made by the professor during the SAHC course of visual inspection: the difference of the blueprints with respect to the real measurements cannot have, in fact, such a wrong level of approximation.

Figure 3.4: The unrealistic difference discovered by the students during their the geometrical survey: the blueprint developed after the theodolite scanning (left) the updated drawing (right) (Ogrizovic et al., 2013)

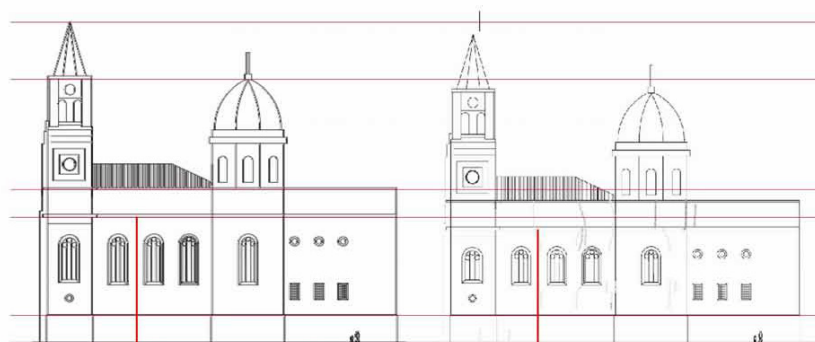
Figure 3.5: Difference in height discovered by the students during their the geometrical survey: (a) the blueprint developed after the theodolite scanning (b) the updated drawing (Ogrizovic et al., 2013)

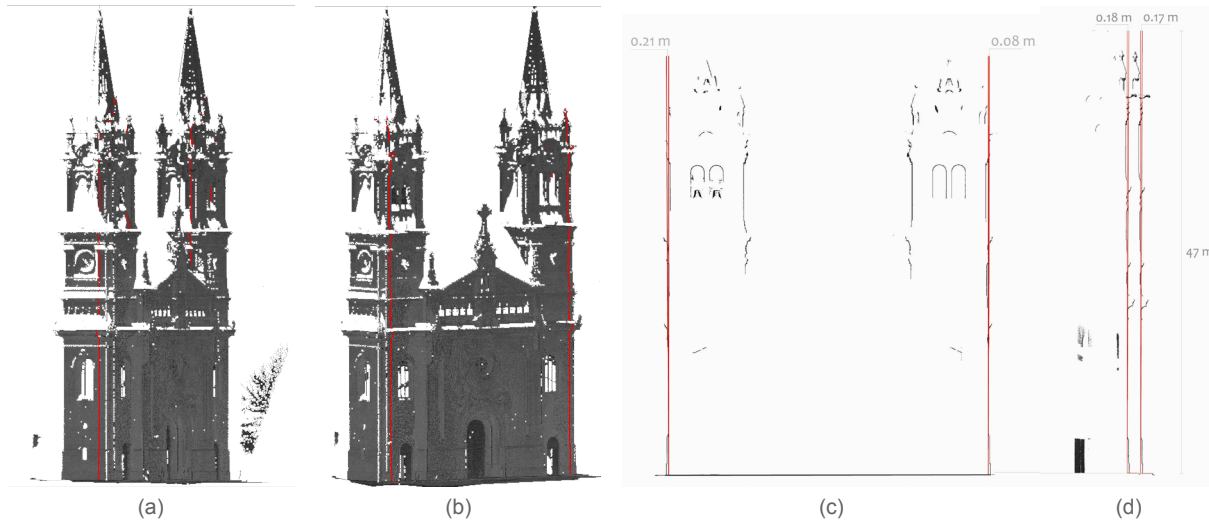
Figure 3.6: The first laser scanning: (a) laser scan of the sides of the church (b) laser scan of the front of the church (c) lateral displacements inferred by the students (d) displacements of the façade inferred by the students (Facelli et al., 2013)

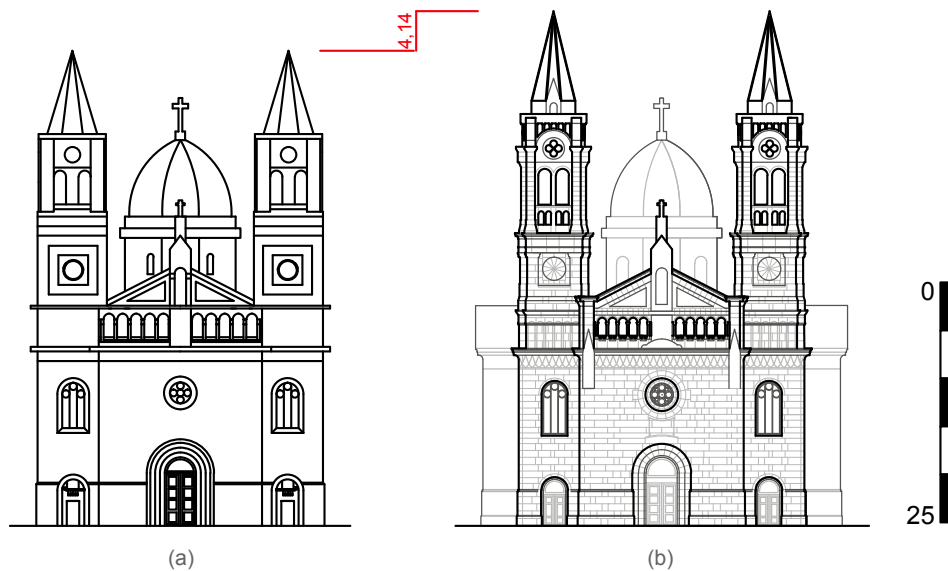
On the 12th of December 2012 a laser scan on the façade of S. Torcato was carried out by Belén Riveiro, a researcher at the University of Vigo. The main aim of this analysis was the update of the plans of the building and the check of the real inclination of the towers (this last part will be discussed in Paragraph 4.3.1.6). Because of the lack of time just two scans were carried out, one in the front and one in the sides of the façade (Figure 3.6). The laser scanning was useful to reveal the mistakes of the drawings and the plans were updated as shown in Figure 3.7.

Figure 3.7: Updating of the building plans (a) the blueprint derived from the theodolite scanning (b) the drawings developed from laser scanning

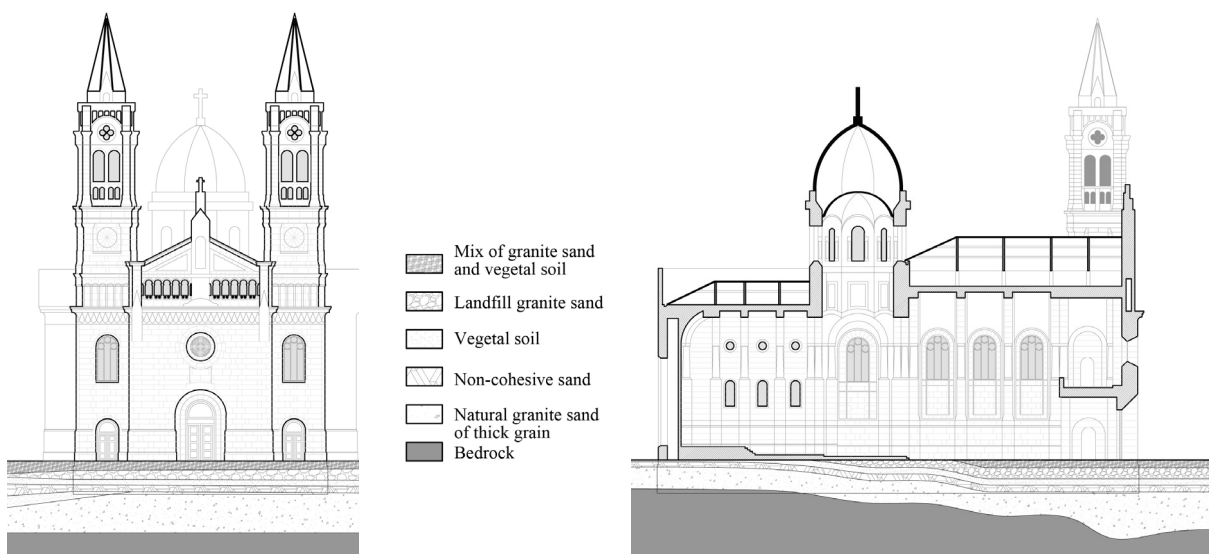
Figure 3.16: Distribution of soil layers according to the geotechnical investigation (Lourenço and Ramos, 1999)

The results of this test are really important, because can imply the presence of a soil settlement as an underlying cause of the cracks. In fact, the building could be affected by differential soil settlement because is standing on various layers with different mechanical behavior. Furthermore, the presence of the cracks in the area that directly supported on the soil with poorest quality could validate such hypothesis.

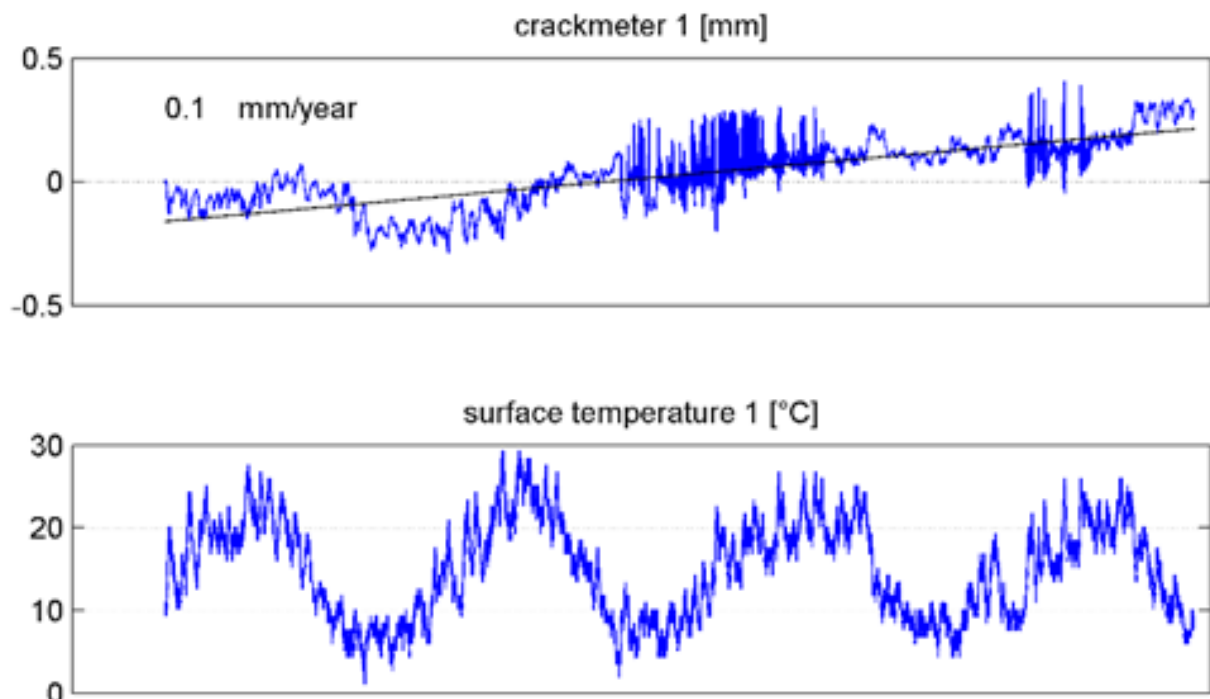
A detailed analysis of the data until today will be described in Chapter 6. However, a brief conclusion that was inferred of the analysis of the data until 2012 will be reported here (Manning et al., 2013). It was found an average crack width increase varying from 0,1 to 0,15 mm/year. The tendency of the cracks follows inversely the temperature trend, that is to say the cracks width increase when the temperatures decrease (Figure 3.20).

Figure 3.20: First results of the LVDT data regarding one of the cracks (Manning et al., 2013)

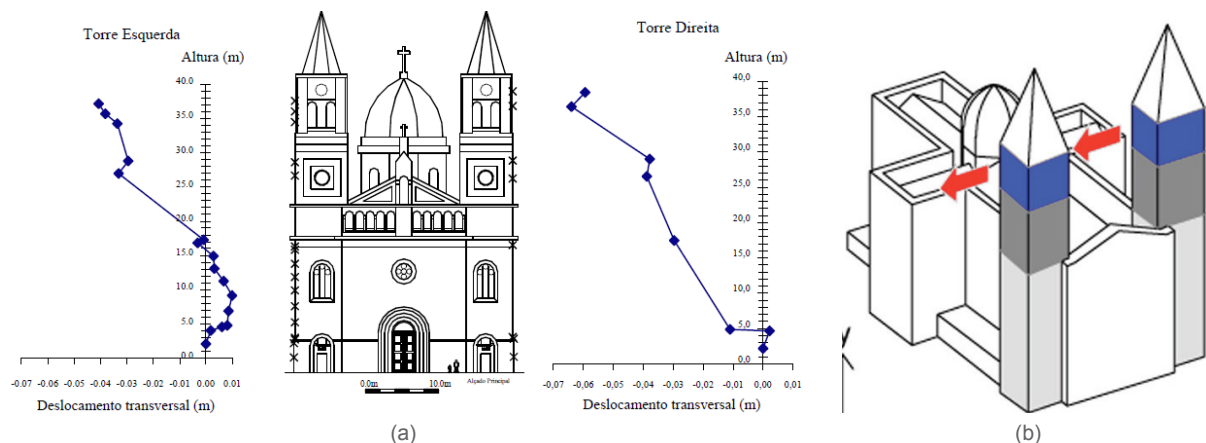
the survey for the arches of the barrel vault. The investigation on the towers shows that both of them are leaning on the same side with differential inclinations of about 0,0016 mm/m (left tower) and 0,0020 mm/m (right tower) (Figure 3.21).

Figure 3.21: Tower displacement monitoring made by means of a optical theodolite: (a) results of the analysis (b) resuming scheme developed by Gutschow (Lourenço and Ramos, 1999)

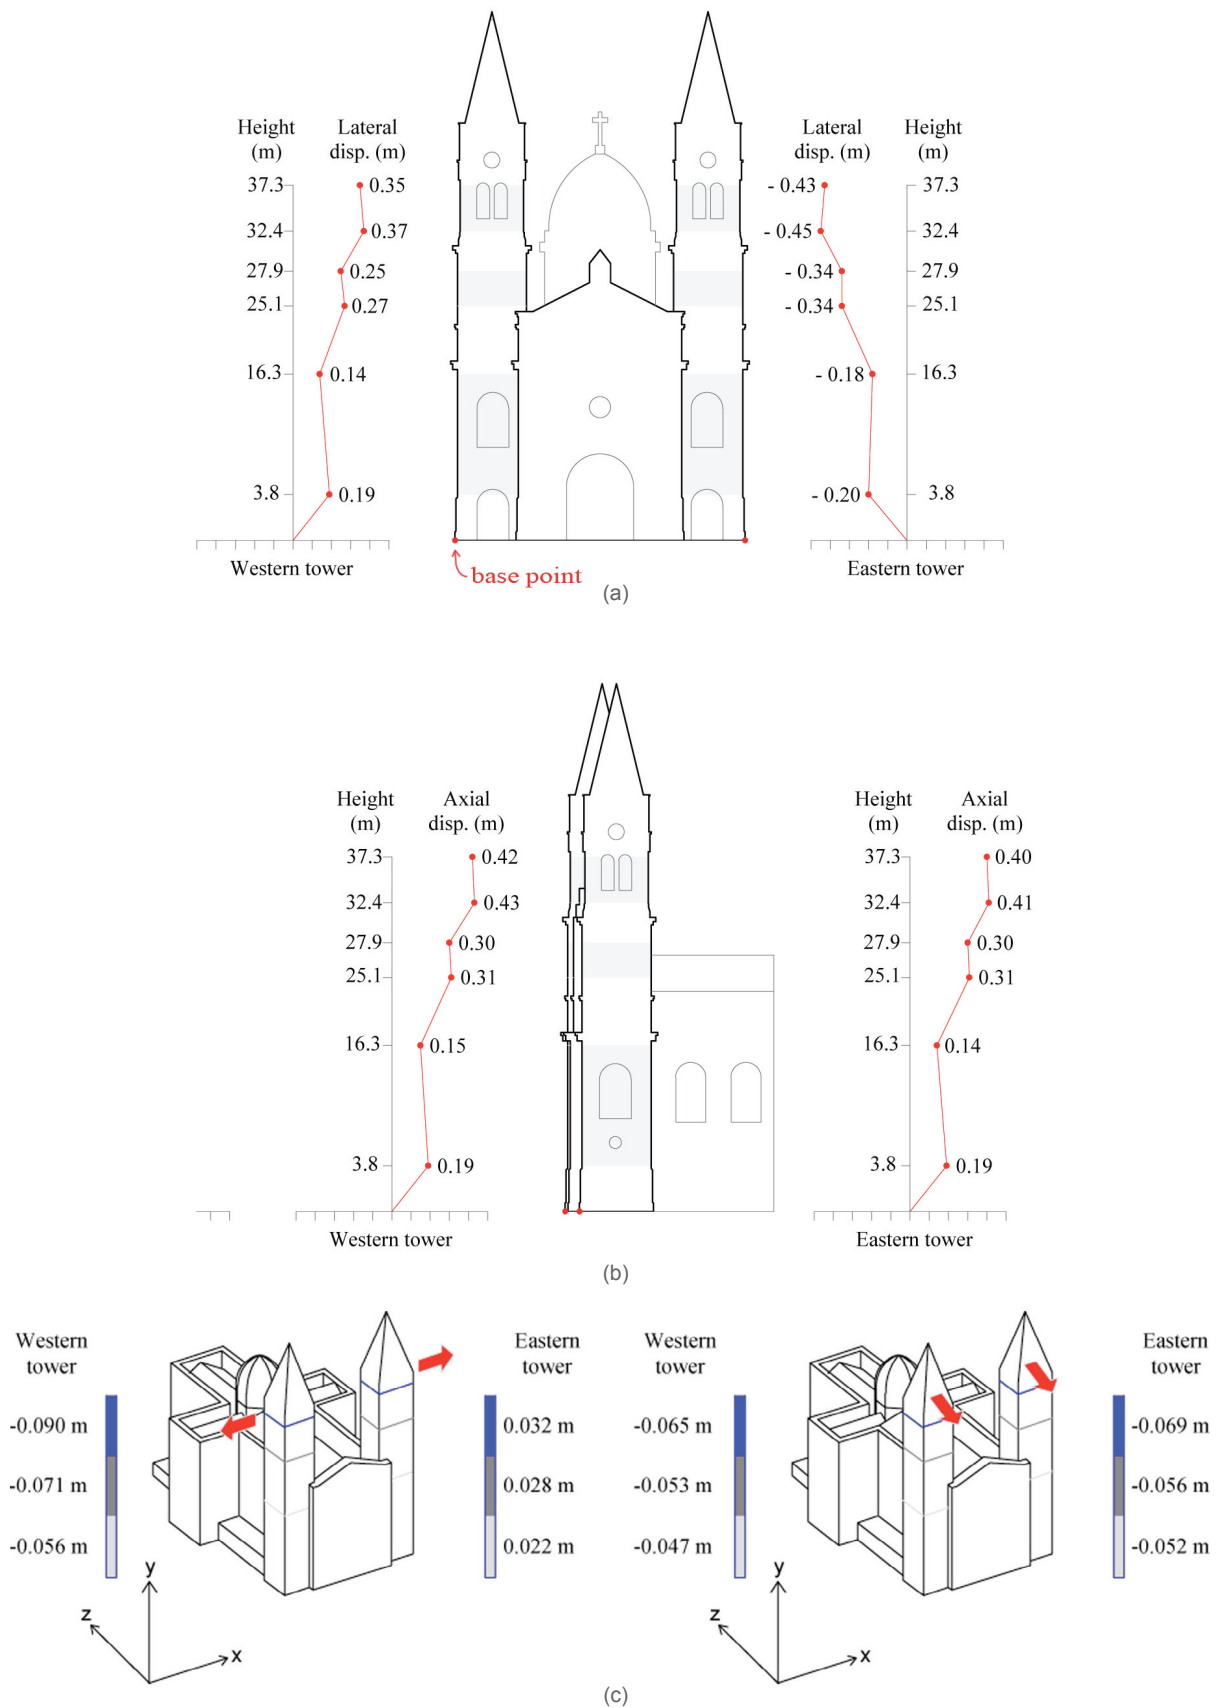
The laser scanning carried out during 2012 permitted to state the real tilting of the towers. Of course this analysis cannot represent the real movements of the structure, because it denotes just the situation at the moment of the snapshot. However, it is possible to confront the data collected during the theodolite survey and the displacements detected by the laser scanning. This comparison shows that to data collected analytically were probably wrong, but it is necessary to remark that the precision of a theodolite is much less than a laser station (Figure 3.22). Further analysis of the tilting, using the monitoring system data, will be carried out and described in Chapter 6.

Figure 3.22: Check of the displacement monitoring by means of a laser scanning: (a) differences in the transversal direction (b) differences in the longitudinal direction (c) remaining scheme of the analyzed displacements (Gutscoven, 2014)

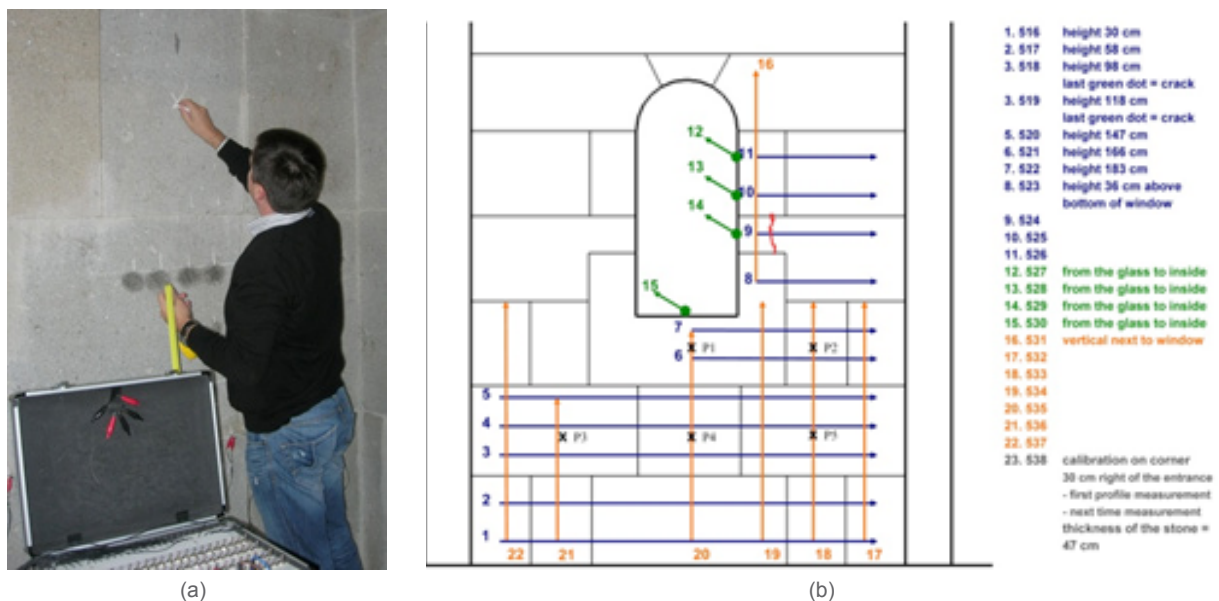
Figure 3.29: Sonic Test Setup: (a) Marking the locations for the sonic tests on the interior northwest wall of the west tower (b) test locations, P1 through P5 (Manning et al., 2013)

Location	Average velocity [m/s]	COV [%]
P 1	2073	1.84
P 2	4220	4.54
P 3	3244	2.39
P 4	3821	3.38
P 5	3322	2.39
Average	3336	24.26

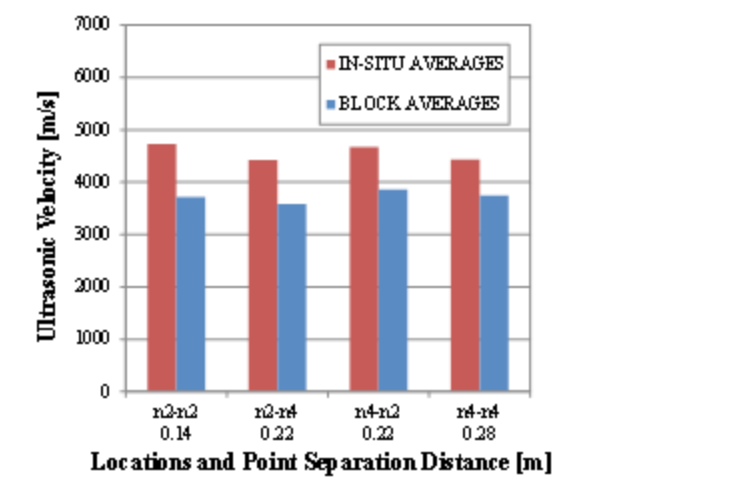
The results of direct ultrasonic tests on the samples were much more consistent with respect to the sonic tests (with an average wave velocity of 3800 m/s) while it was not possible to make a comparison between indirect tests due to high variability of sonic. The average value for semi-direct tests was around 3700 m/s, with the velocity of the second specimen slightly higher than the first one. The semi-direct ultrasonic tests performed in-situ showed an average speed around 4500 m/s (as for the specimen's sonic tests). The sets of points and their relative distance were similar in the specimen and in the building, thus it was possible to compare the two granites. The values taken from the building are considerably higher than the specimens, and this could suggest that the material from the quarry was different in mechanical properties or in composition. However, the different environmental conditions (such humidity and temperature) could have affected the results of the tests. A numerical comparison of the measurements can be seen below.

Figure 3.31: Comparison of semi-direct ultrasonic tests in-situ and in separate granite blocks (Manning et al., 2013)

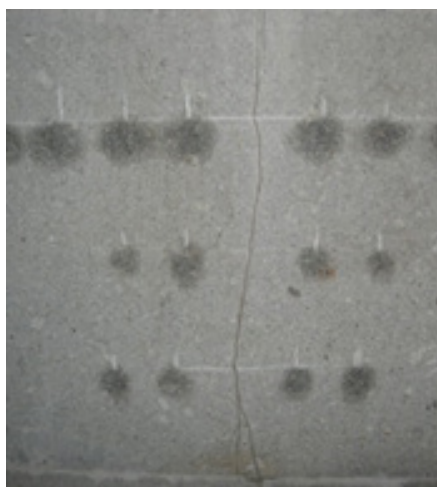
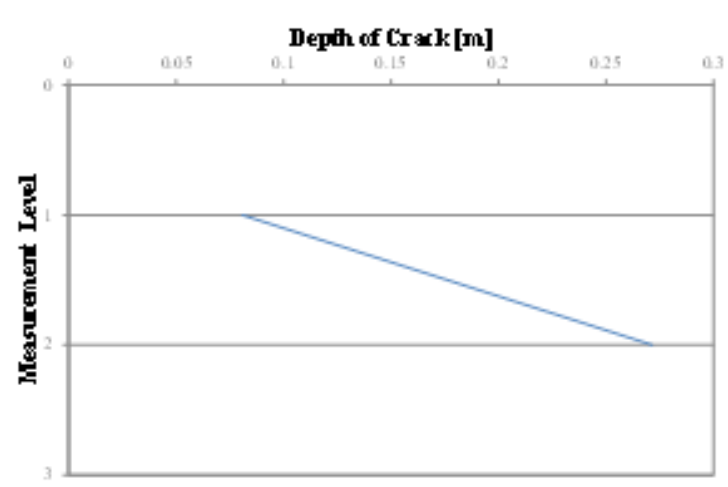
Figure 3.32: Ultrasonic tests over a crack in the west tower of the S. Torcato church (a) locations and levels of the crack depth readings (b) crack depth results (Manning et al., 2013)

Another set of tests was performed also to define the depth of a crack visible in the exterior wall of the left tower. The fissure was measured at three different heights resulting on a maximal depth of 25 cm (Figure 3.32).

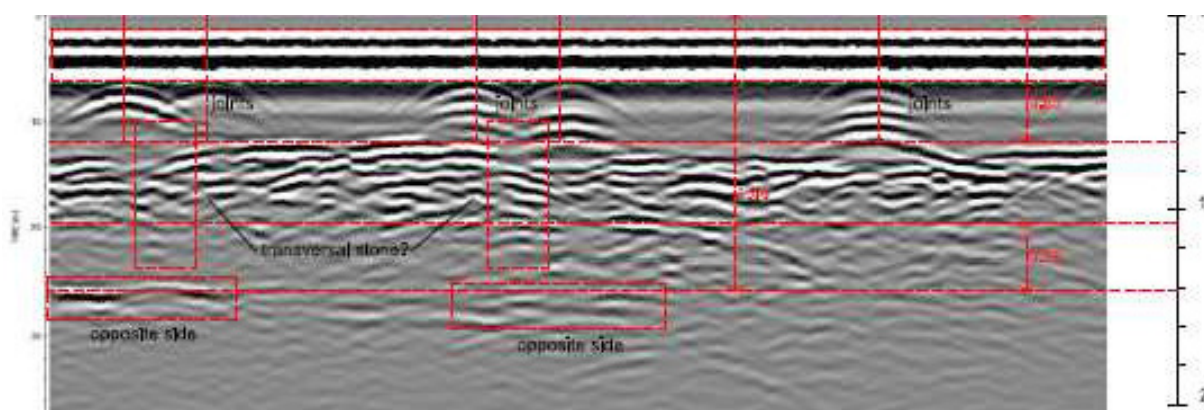
distributed through the thickness of the wall: the surface, an irregular layer and the last area defined by the interior leaf of the wall (Figure 3.34). Due to the high level of noise in the internal layer, the student inferred that the wall could not be massive and instead a multi-leaf constructive method was used for the transept. The thickness of those layers is: 65 cm for the exterior side, 35 cm for the interior and 40 cm for the infill, with a total of 140 cm. Because of the interference of the signal, they also considered the possibility that the stone was well worked just in the surface while the other sides were worked in a coarse way. Passing-through stones were also discovered by means of this analysis. The interesting conclusion proposed by the student was the drawing of the most likely section of the transept wall, shown in Figure 3.35.

Figure 3.34: The output of one of the GPR horizontal tests (Guzmán Corredor et al., 2013)

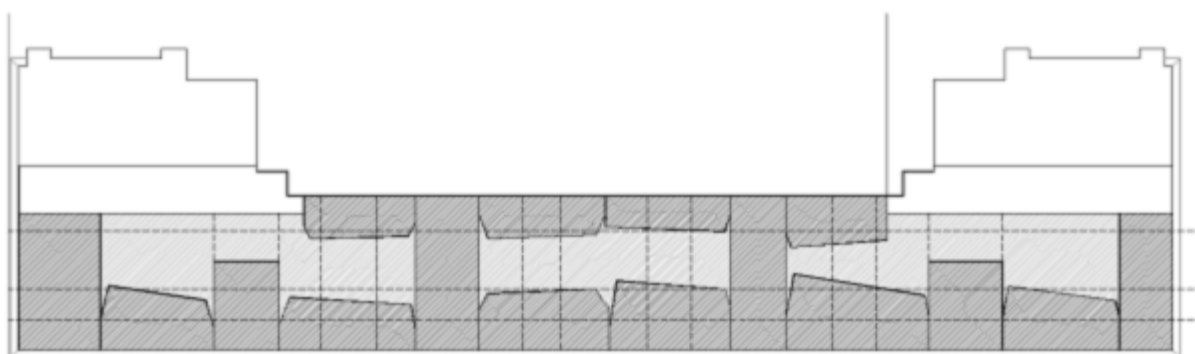
Figure 3.35: The horizontal section based on the analysis of GPR output (Guzmán Corredor et al., 2013)

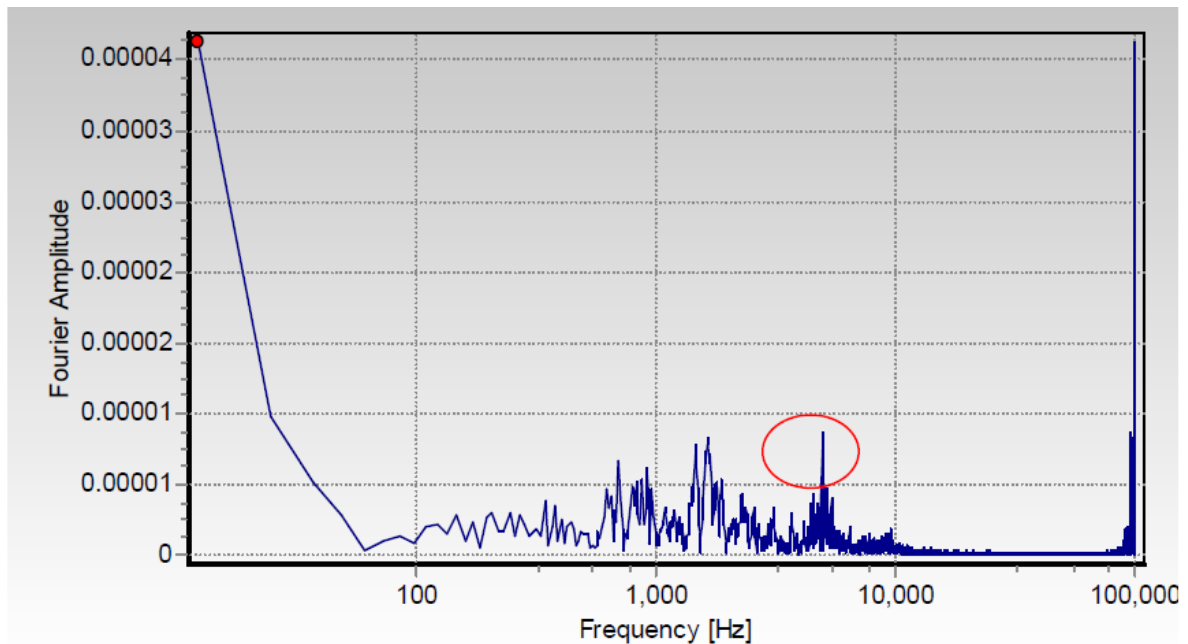
Figure 3.36: The Fourier spectrum from the test on the vault (Greco et al., 2013)

a thickness of the vault of 28 cm; this measurement was then checked and confirmed lately by means of a Boroscopic camera, with the relative error of 10 %.

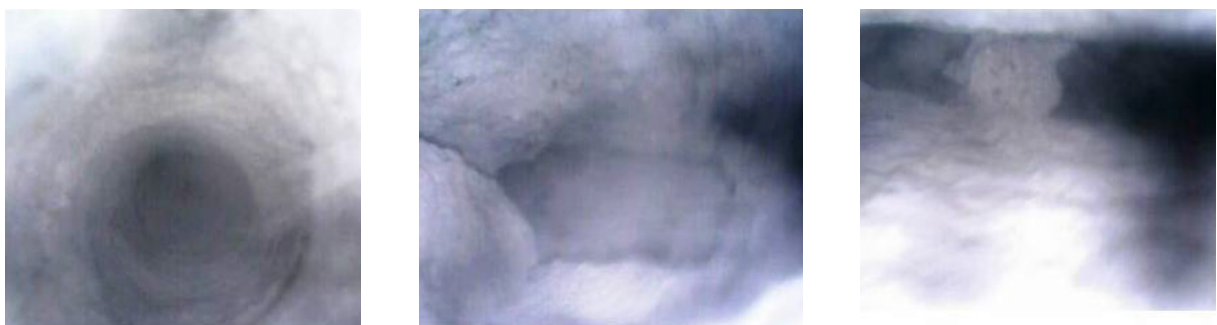
Figure 3.35: Borehole, from left to right, the regular section of the whole changes to irregular and then a big void appears at the depth of 60 cm (Guimarães et al., 2013)

was around 25 cm and was probably made by hollow-brick quarterdecks. For the test performed on the choir, a crack was chosen as place to analyze so that the drilling was minimized. It was possible to check until 60 cm, and during the survey was discovered the presence of non-adherent layers of concrete (Figure 3.38). Another crack was used as base for the analysis of the façade. In this case, the light at the end of the hole demonstrated that the fracture passes through the entire wall (Figure 3.39).

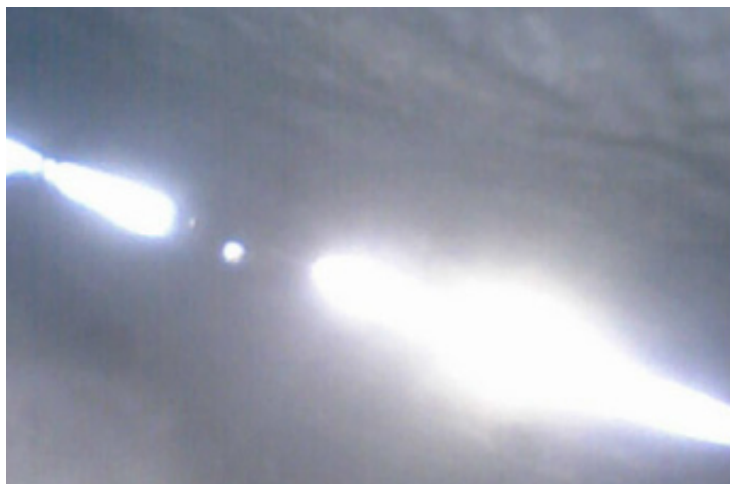
Figure 3.39: Boroscopic test image from the façade (Guimarães et al., 2013)

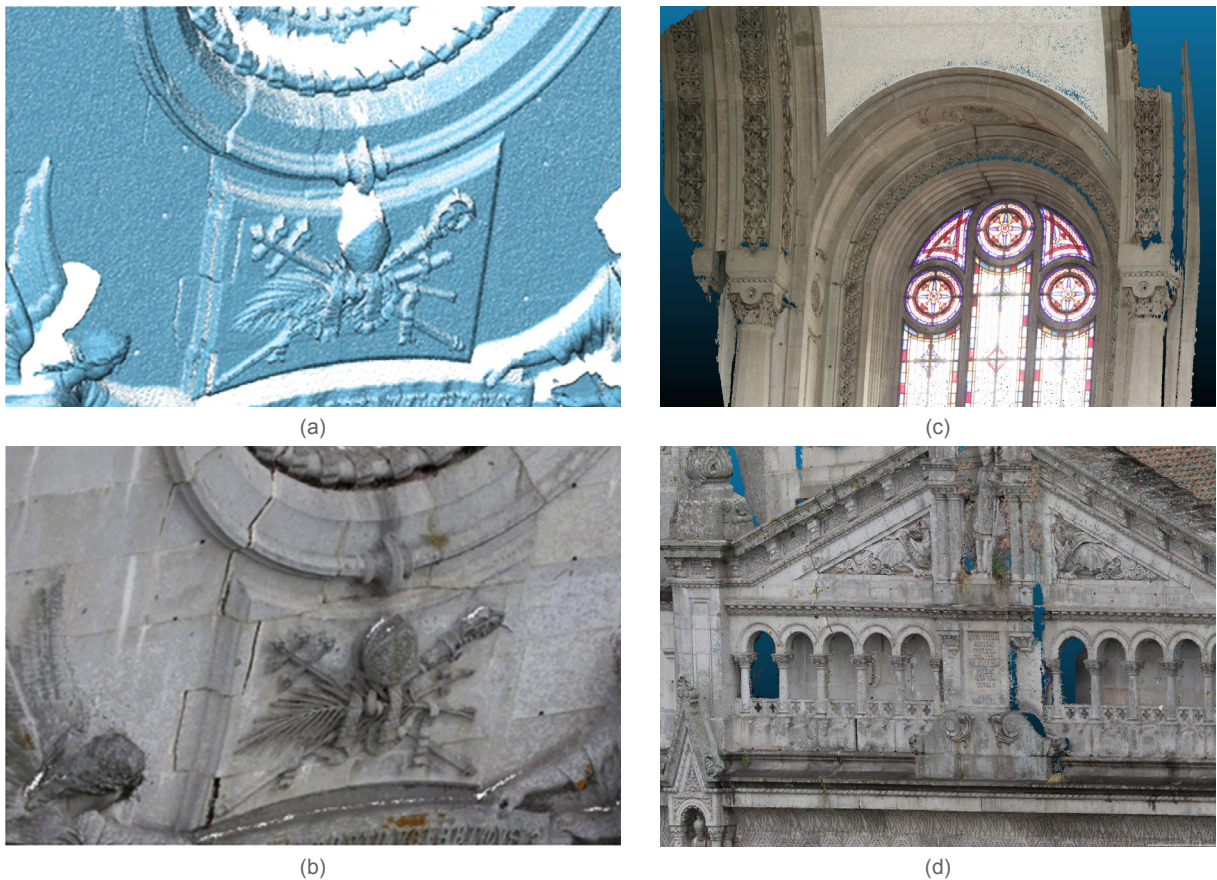
This method is suitable for the analysis of parts that are difficult or impossible to reach by the operator of the laser scanner, like the backside of the spires or the roof. The main improvement with respect to a laser scanning is the possibility of apply photo-realistic textures on the model. In this way it is easy to establish the crack pattern and have a global idea of the damage. The crack pattern revealed on the building can be added on the final FE model so that is possible to check the real behavior of the structure. If the method is repeated during a long range of time, it should be possible to check the crack development too.

Figure 3.42: Results of the photogrammetry: (a) the image obtained from the laser is too precise and the flat to notice the crack (b) with photogrammetric textured model the crack is more visible (c) a detail (d) exterior balcony (Sánchez Aparicio et al., 2014)

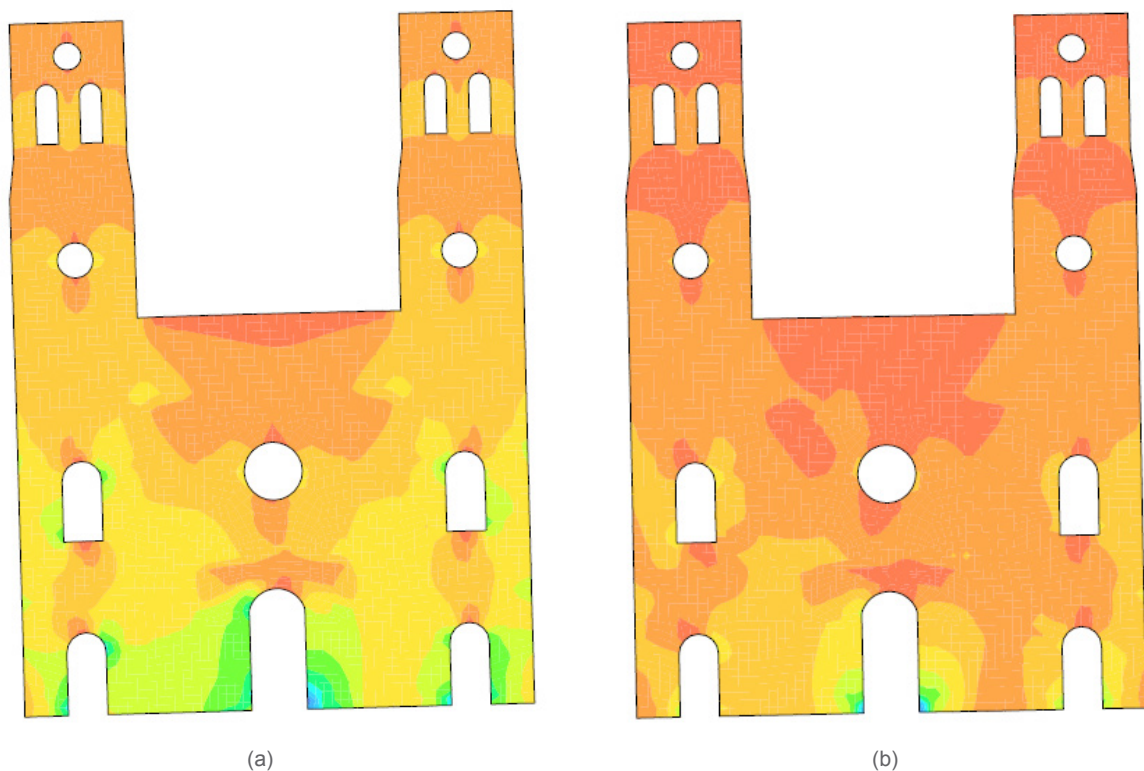
The linear analysis of the model showed a range of stresses varying from -2,5 MPa to 2,5 MPa and a rotation of the building that follows the distribution of soil properties, as expected (Figure 3.44). From this value of tension it can be inferred that the material will crack. The position of the potential crack fits the damage pattern of the structure: a tensile stress concentration is present on top of the rosette and follows a triangular pattern until the top of the tympanum. It was also discovered that applying the construction phases the results were not affected.

The results of the non-linear model were slightly different. The range of the stress is going from -4,5 MPa to 0,2 MPa. The distribution of stresses is not symmetrical due to the settlement of the structure. The crack pattern in the FE model is in agreement with the real damage distribution of the real building. It can be inferred that the structural defects on the structured can be attributed to differential settlement on the foundations. The tilting measured with the optical theodolite was compared with the displacements found in the FE model. Even is the distribution of the displacements along the FE tower were difficult to understand, it was found a rotation of 0,0016 mm/m, value that approximate the rotation detected on the real structure (around $15 - 25 \times 10^{-3}$ mm/m).

Table 3.44 The result of the linear 2D analysis, the gradient shows the minimal principal stresses distribution (a) linear model with range from -2,5 MPa, in blue, to 2,5 MPa, in red (b) non-linear model with range from -4,3 MPa, in blue, to 0,2 MPa, in red (Lourenço and Ramos, 1999)

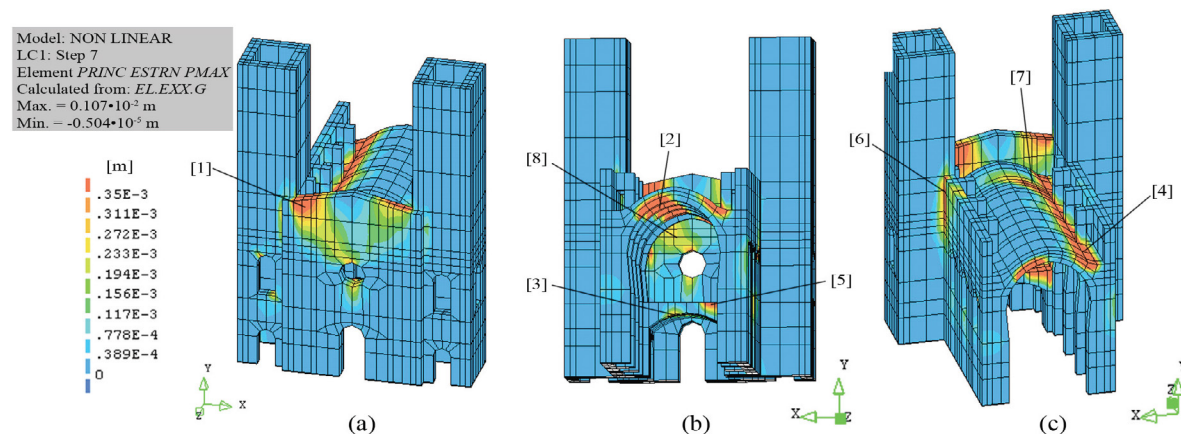
More interesting are the results of the analysis that takes into account the interaction with the soil. The displacements found in this analysis are similar to the previous 2D case, but the strain pattern is has a really good approximation of the real damage of the building. The strain distribution range is much more realistic, reaching maximal tension stresses of 0,9 MPa (compatible with the material) and maximal compression values of 7,0 MPa, that could represent the risk of incipient collapse of some part of the building (namely the arches). The left tower settlement reaches 0,19 m and the differential settlement of the tower with respect to the first arch is 8,1 cm, a value that represent closely the situation detected during the theodolite scanning. However, The difference between the first and the fourth arch is too elevated with the differential settlement identified during the pavement survey.

This FEM analysis definitely confirmed that the damage of the building is due to soil settlement. However, some cracks that are not present in the real structure were found (see Figure 3.49, number 6). The cracks on the main vault are more central than the one resulting from the FEM (see Figure 3.49, number 6). Furthermore, in the interior of the façade just one crack is developing while in the reality there are two slits (see Figure 3.49, number 8). For all this reason, even if the results are really good and give a significant explanation on the damage causes, it was considered necessary to update the model by means of dynamic system data.

Figure 3.49: Strains [m] of the non-linear model with soil interaction (Lourenço and Ramos, 1999)

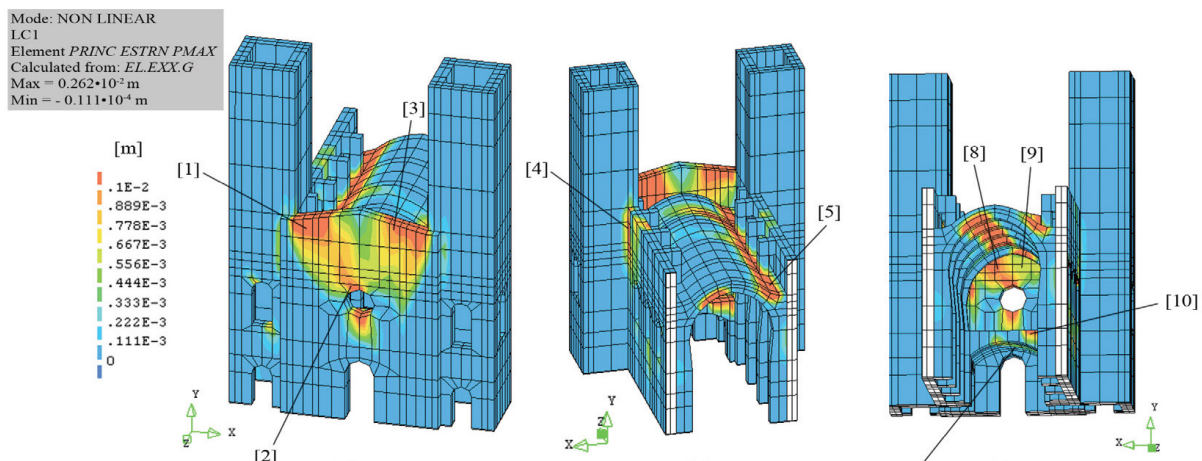
Figure 3.50: Strains of the optimized model with soil interaction (Ramos et al., 2012)

Some properties of the model were calibrated by means of the Douglas-Reid method, implemented considering lower and upper bounds for the updating variables (Table 3.5). A difference in value of 80% was found in the first model with respect to the updated. The Model Assurance Criterion (MAC) was used to compare the numerical model with the experimental results. The reliability of the updated model with respect to the experimental data can be seen in the Figure 3.51. The analysis carried out on the updated model was able to recreate the real crack pattern in a better way (Figure 3.50). All the mistakes described in the previous paragraph concerning the non-linear 3D FEM are now reduced. The adjustment induced to the Young's modulus has led to an increase of tensile stresses in the façade, which now presents a crack more similar to the real one.

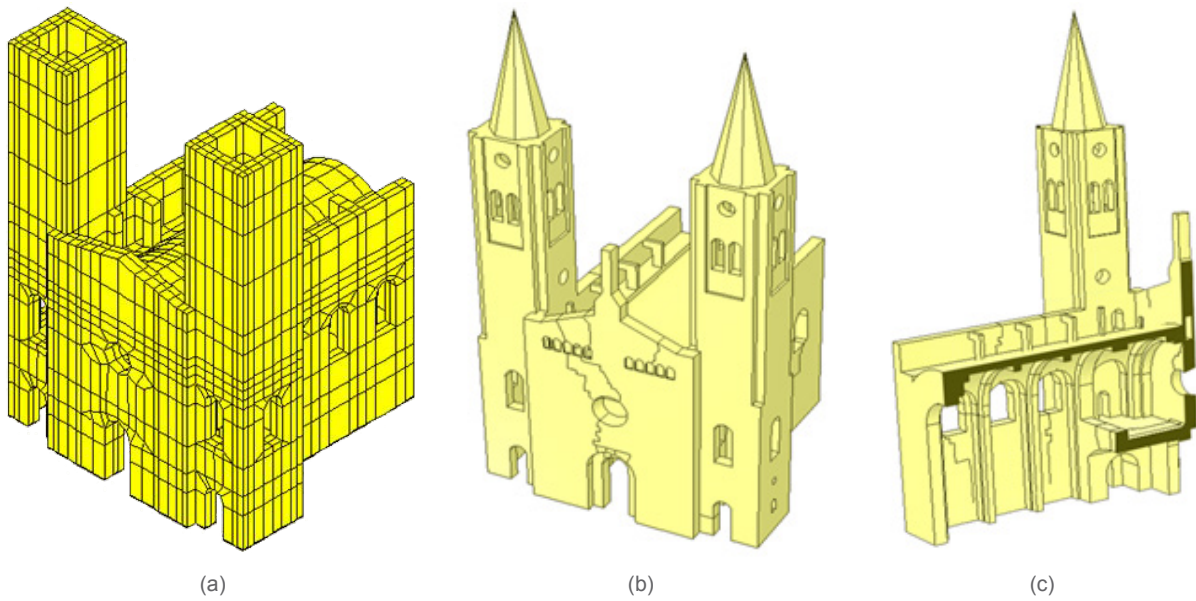
Figure 3.56: The model used by for the FEM updating: (a) view of the whole meshed model (b) cracks added on the façade (c) crack pattern considered in the interior of the church (Sánchez Aparicio, 2014)

presence of the crack on the façade. Consider the crack pattern on the model changes substantially the global properties that define the building behavior: the elastic modulus is higher than the previous update and the specific weight is more precise (Table 3.6). A complete FEM analysis with the last updated properties will be carried out soon, and surely it will define the building behavior in a more precise way.
